OZARK LEAD TAILINGS DAM
REYNOLDS COUNTY, MISSOURI
MO 30160

PHASE 1 INSPECTION REPORT NATIONAL DAM SAFETY INSPECTION

APRIL 1981

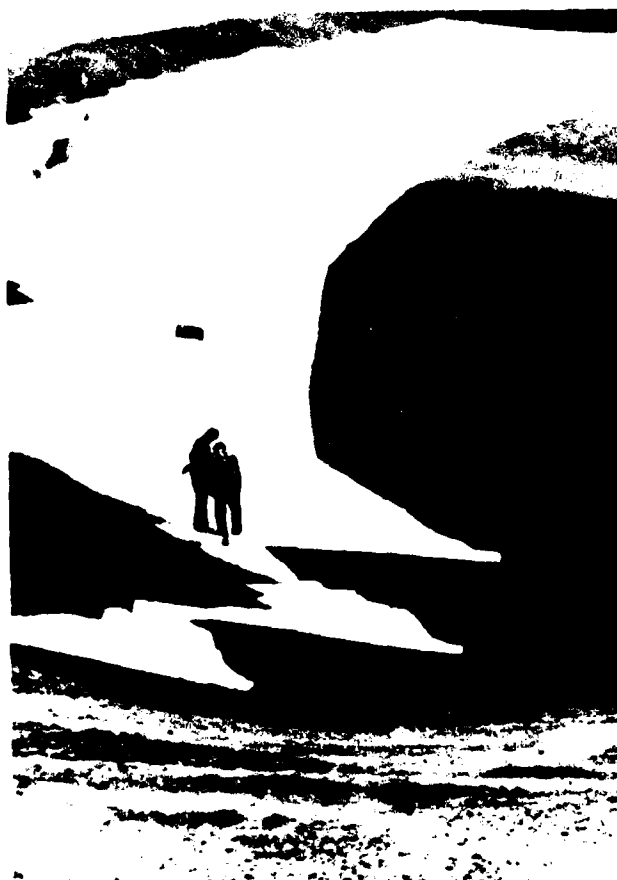
2. Filter fabric and gravel drain being installed during modifications to dam. Note abundant seepage (dark area below fabric) and erosion due to seepage water. Looking east from right abutment. Photo by Ozark Lead Company (1979 or 1980).
